Replacing A TR8 Gearbox by Bob Thomas

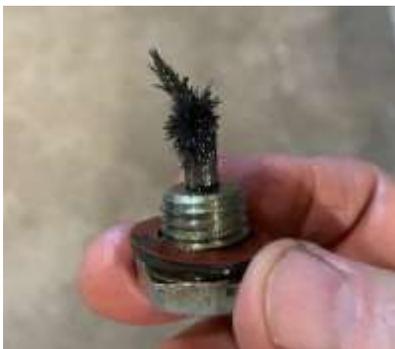
With the car up on my 4 post lift, the gearbox oil was drained (Picture 1 shows more metal pickup on the magnet than normal).

Picture 1. Excess metal on drain plug magnet.

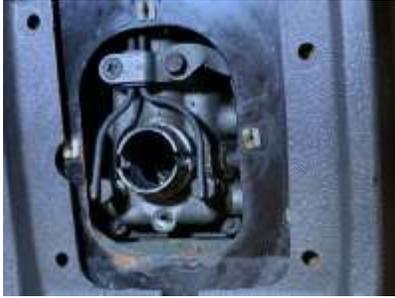
Picture 2. Gear shift removed.

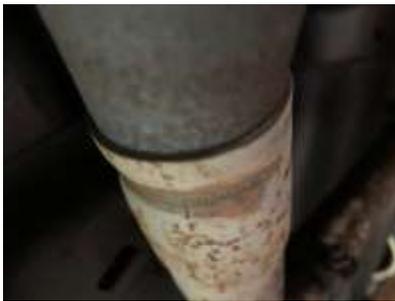
Now it was time to drop the exhaust and that's when the trouble started. A DPO (dreaded previous owner) or DPM (dreaded previous mechanic) had over tightened a clamp at one of the header extension/intermediate pipe joints creating a deep ridge (Picture 3) so they wouldn't budge, even with heat from a propane torch.

Picture 3. Result of an over-tightened clamp.

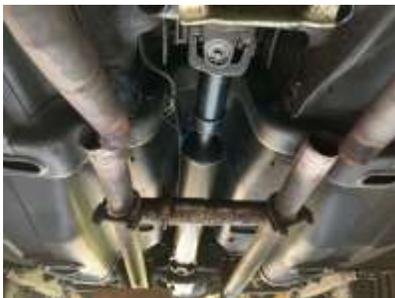
Picture 4. Exhaust finally apart.

The good news was that my neighbour is a mobile mechanic. The bad news was that it took 2 weeks before he had time to come over with his oxy-acetylene torch. Eventually with the pipes red hot, and a lot of pounding, the slip joint released and the pipes came apart (Picture 4).

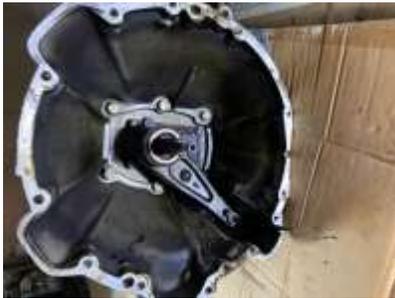
An inspection of the removed gearbox revealed excessive play in the input shaft, a worn throwout bearing and quite a bit of oil around the inside of the bell housing (seen in Picture 5).

Picture 5. Oil inside bell housing.

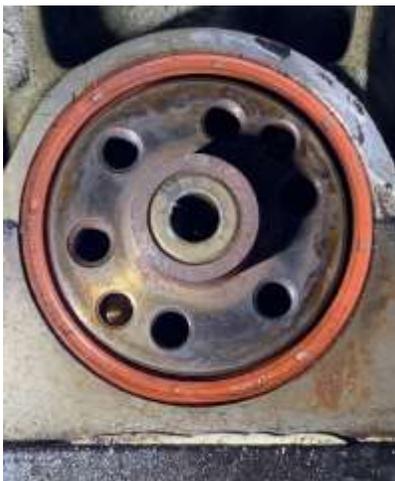
Fortunately the rear main seal was dry, but there appears to be no oil pan seal, just a thick bead of sealant that has some gaps (Picture 6).

Picture 6. Sealant (no gasket) on oil pan.

A TR8 engine has to be lifted so the oil pan can clear the power steering rack in order to install an oil pan seal. It seems someone took a shortcut in the past and only used a bead of sealant between the pan and engine block that has hardened over time, allowing pieces to split off and oil to leak into the bell housing.

Other than a scare from the new header gaskets smoking as the coating burned off at start up, the test drive went well. The "growling noise" is gone and acceleration is definitely quicker with the lightened flywheel. The shifting action is a bit stiffer, but hopefully that will get better with more use. Not wanting to contaminate the new clutch and flywheel with engine oil, I parked my TR8 for the winter even though it was still early in October. My first job next spring will be to remove the oil pan and install a proper gasket.

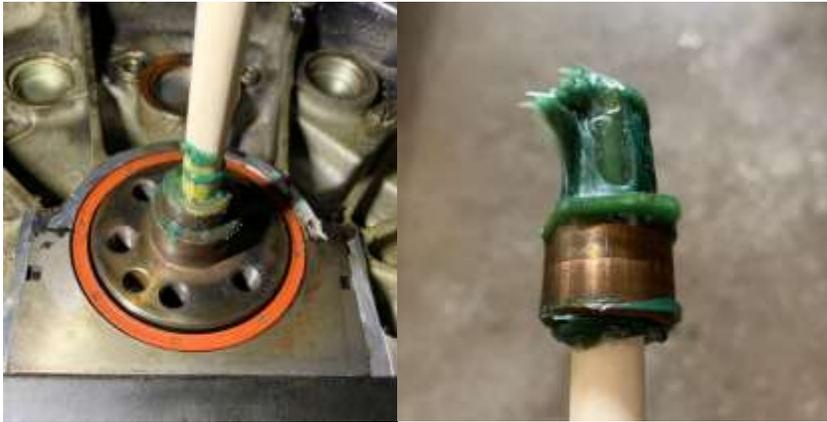
Pictures 7 and 8. Using grease to remove pilot bushing.

Over the next week, the bell housing was cleaned and fitted with a new throw out bearing, clutch fork, and fork pivot. I learned that the "grease trick" for removing a pilot bushing does work, providing the wooden dowel is the same size as the bushing opening (Pictures 7 and 8).

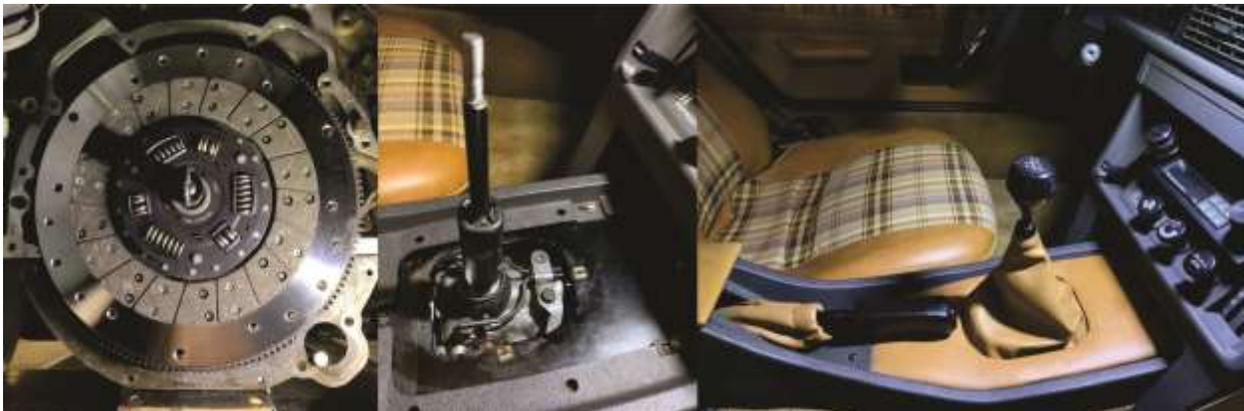
Pictures 9, 10, and 11. Final assembly.

After a new pilot bushing, lightened flywheel, clutch disc, and pressure plate were installed, the car was ready to receive the rebuilt gearbox (Pictures 9, 10, and 11).
