TO: All Dealers

BULLETIN: #T-62-10

SUBJECT: PLUNGER RETAINER (RACK & PINION ASSY.)TRIUMPH HERALD

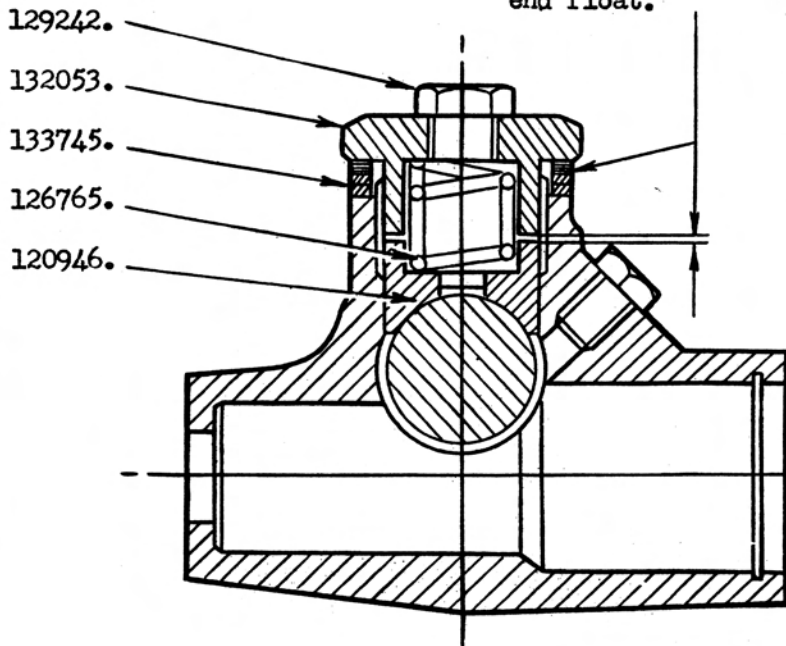
Some steering units incorporate a circlip and spring plate to retain the plunger in the rack and pinion assembly. Should circlip failure occur, modify the unit to the current screwed cap and spring method of retaining the plunger, as illustrated overleaf and described below:

Use shims 120949 and 120959 as required to give 0.004" - 0.008" (0.1- 0.2 mm.) plunger end float.

This method of securing plunger may be incorporated on Part Number 205628 and 304737 when serviced for complaint of circlip not holding in position.

1. Remove and dismantle the steering unit as described in the Service Manual (Group 4).
  2. Tap the plunger boss housing to a depth of - .44" (12.2 mm). using a 15/16" UNF. 16 TPI tap.
  3. Thoroughly clean the housing and pack with the correct grade of grease when refitting the rack and pinion.
  4. Fit new plunger 120946; spring 126765; and screwed cap 132053; placing two packing washers 133745, and sufficient shims 120949 and 120959 between the cap and housing to obtain correct end float.
- NOTE: The end float should be between .004" to .008" (0.1 to 0.2 mm) or the minimum amount consistent with free movement from lock to lock.
5. Refit the steering unit.
