TR6 Rear Inner Fender Splashguards

Ottawa Valley Triumph Club (OVTC)

28 November 1017

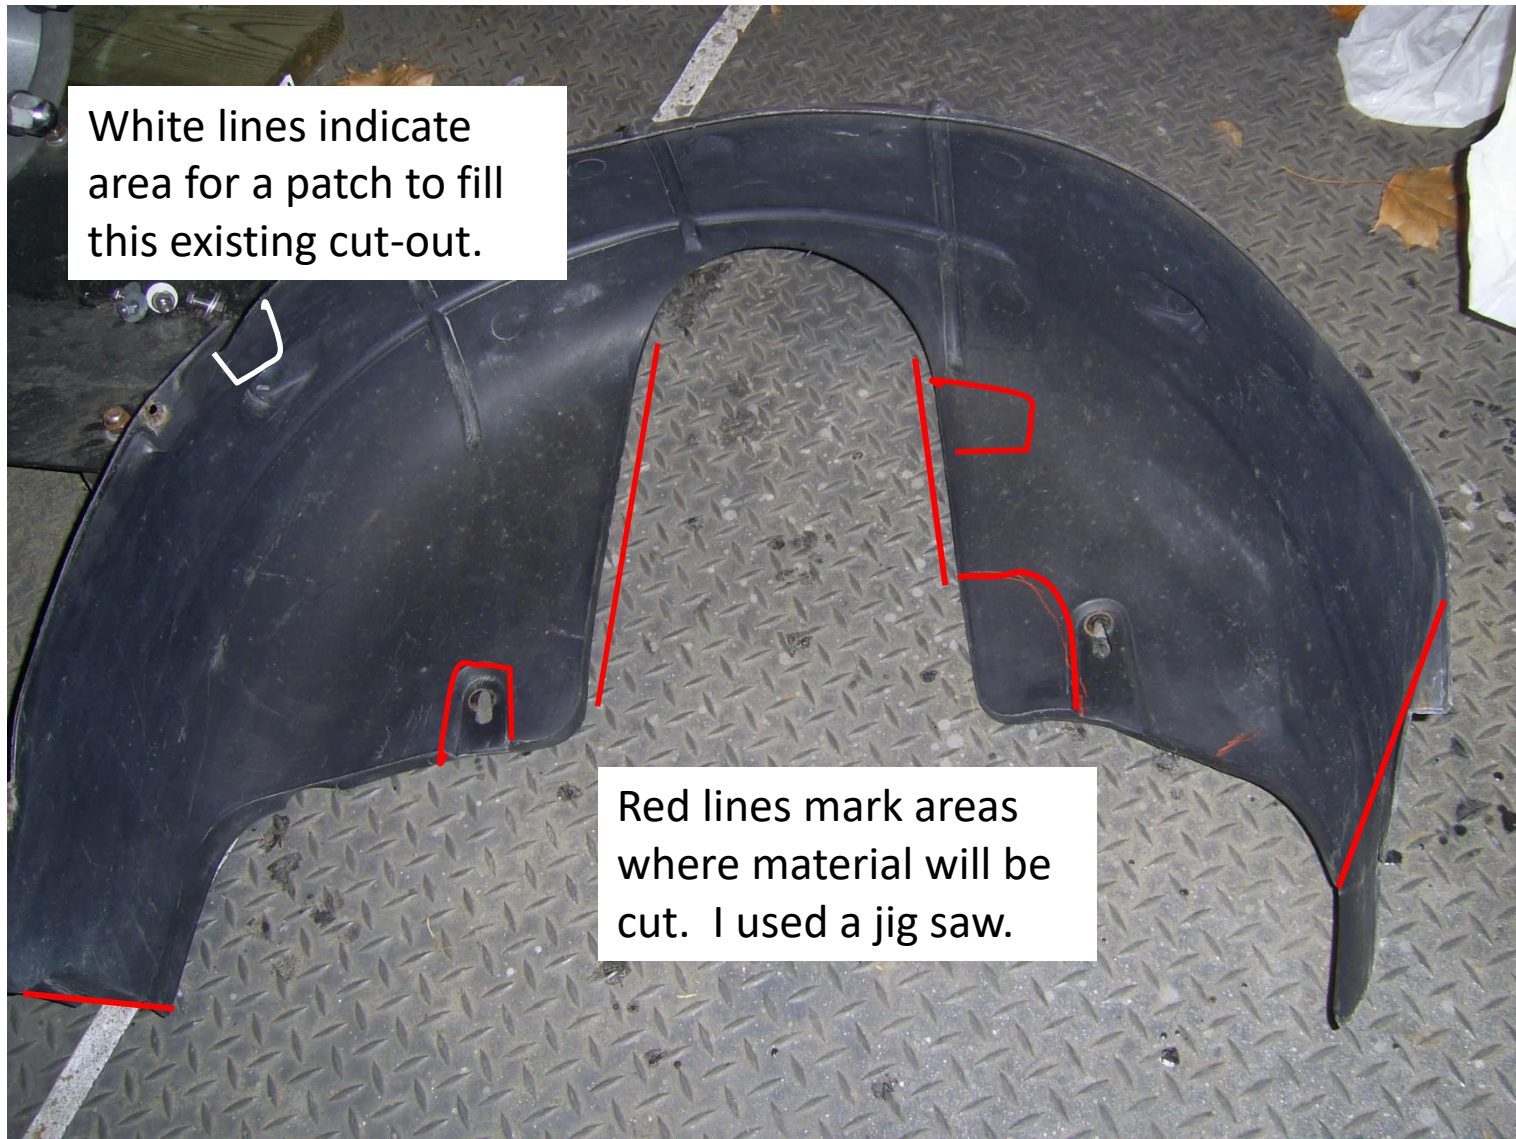
The Splashguard

White lines indicate area for a patch to fill this existing cut-out.

Red lines mark areas where material will be cut. I used a jig saw.

- In order to have the inner shield fit flat against the car inner body wall, I cut:
 - Off the $\frac{1}{4}$ to $\frac{1}{2}$ inch lip on both the inner sides.
 - Off the 90 degree piece pointing to the rear of the splashguard.
 - Off the excess at the bottom of the front arch.
 - Out the existing front facing mounting indent and re-welded a flat piece in that space. The rear indent looks okay as is.

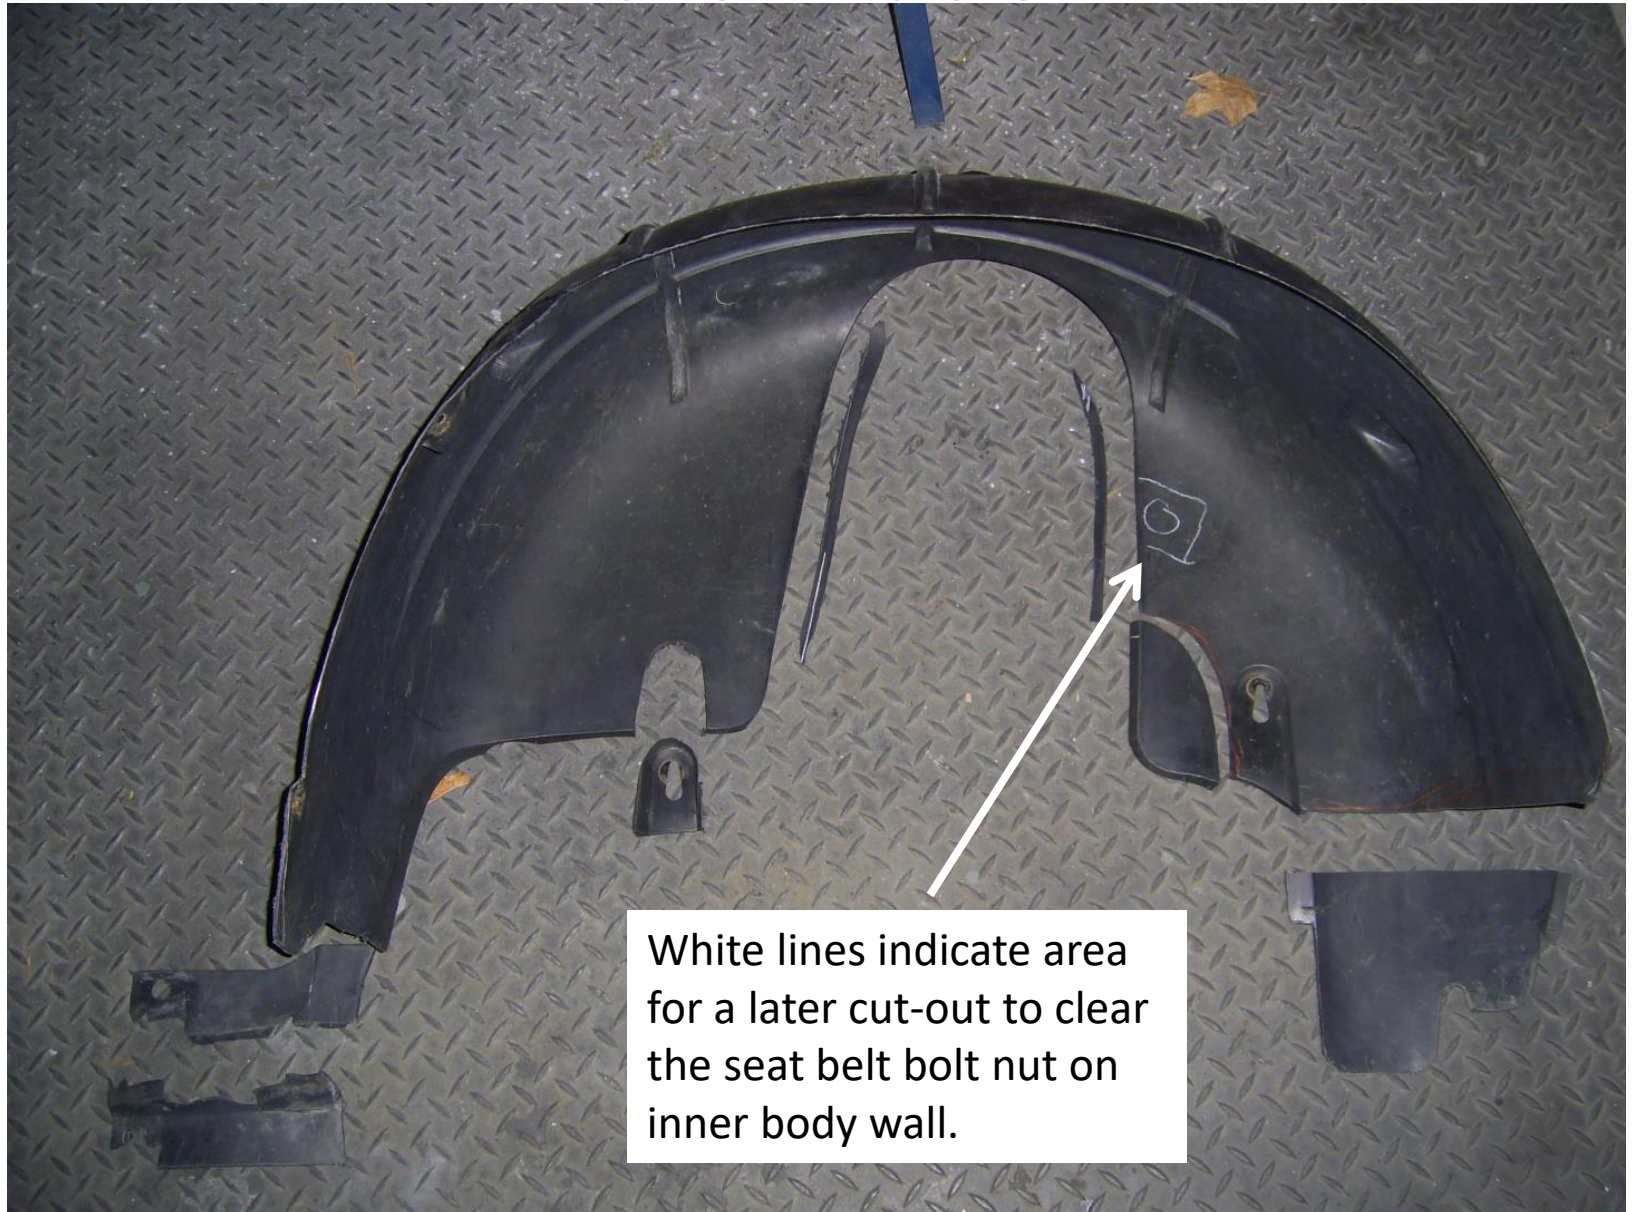
Cuts Made

White lines indicate area for a later cut-out to clear the seat belt bolt nut on inner body wall.

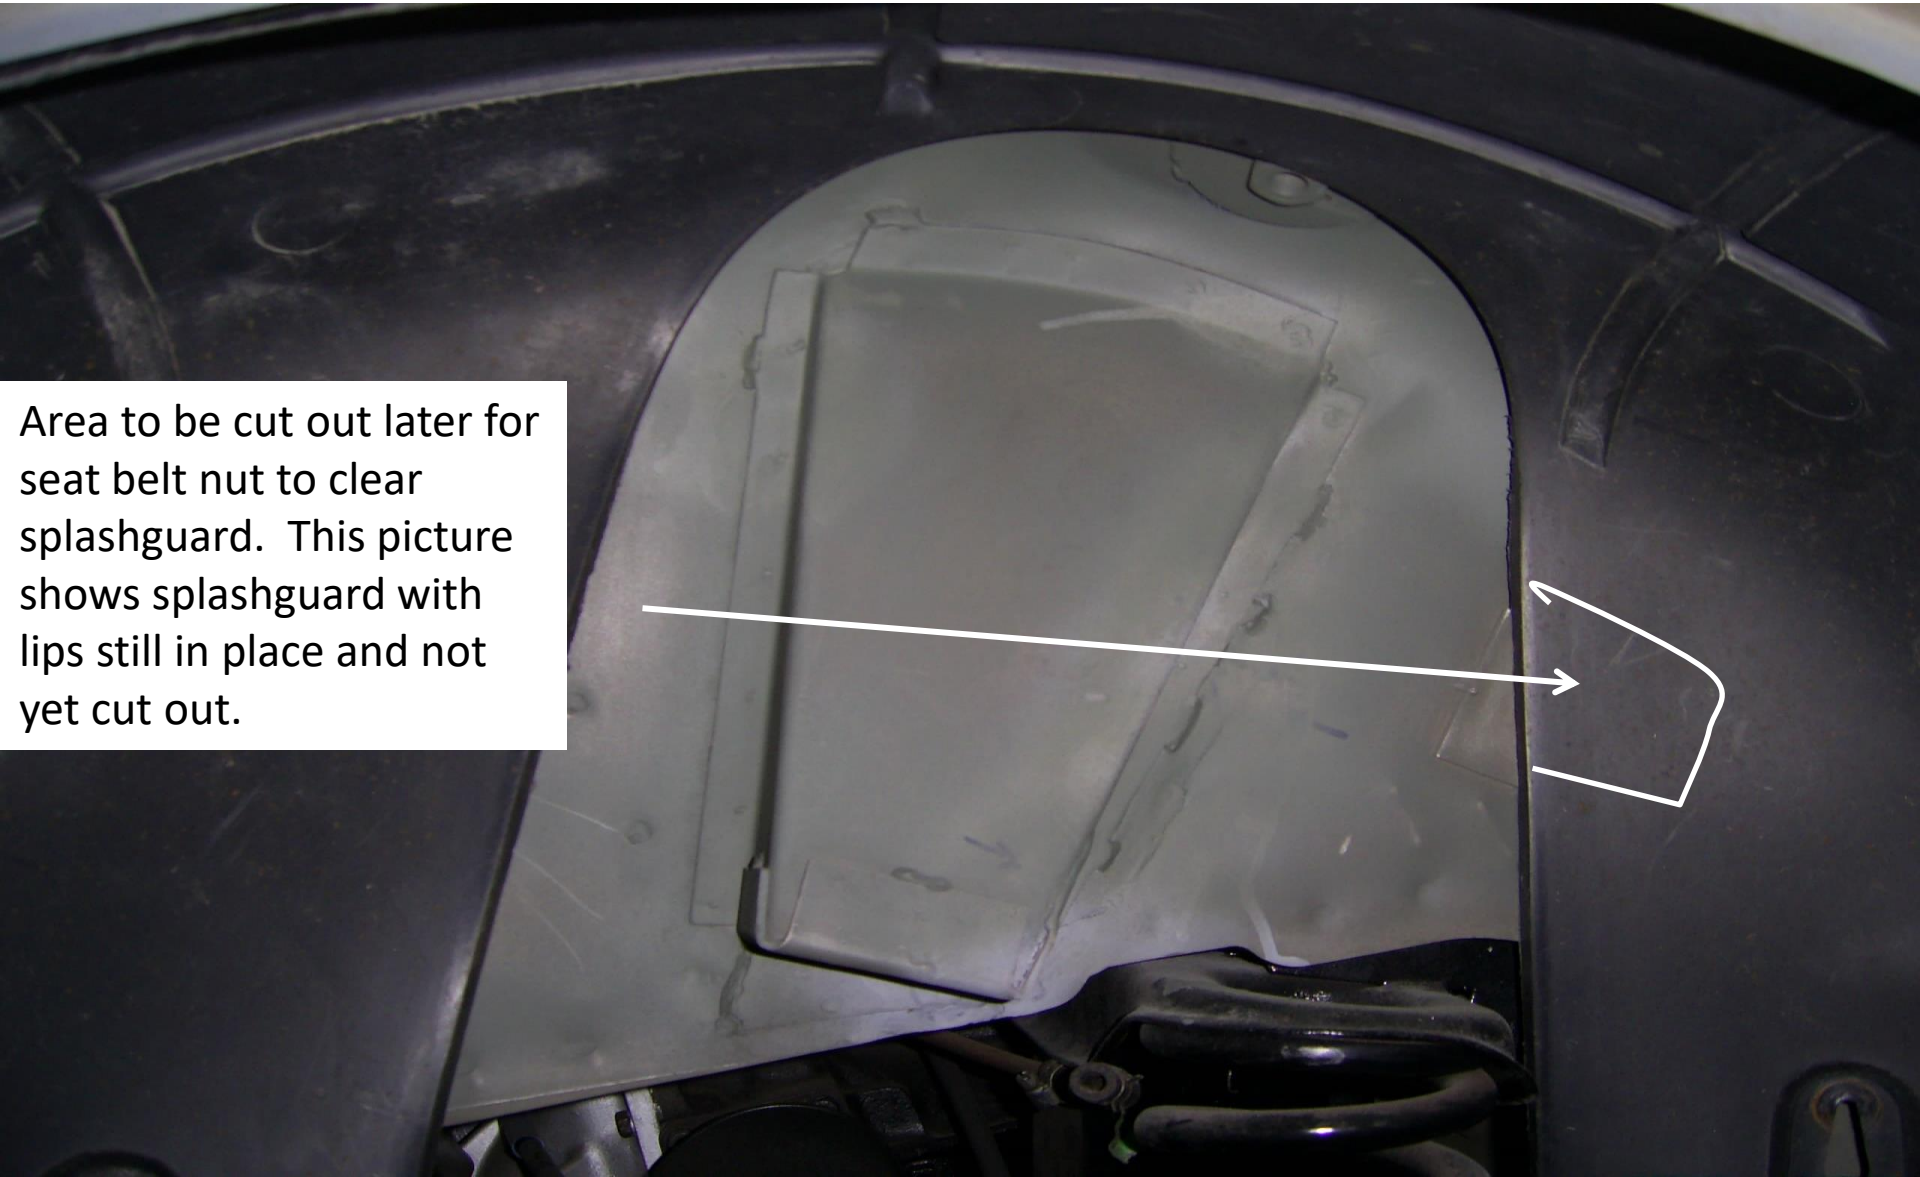
The IRS Bumper Stop Fit

Area to be cut out later for seat belt nut to clear splashguard. This picture shows splashguard with lips still in place and not yet cut out.

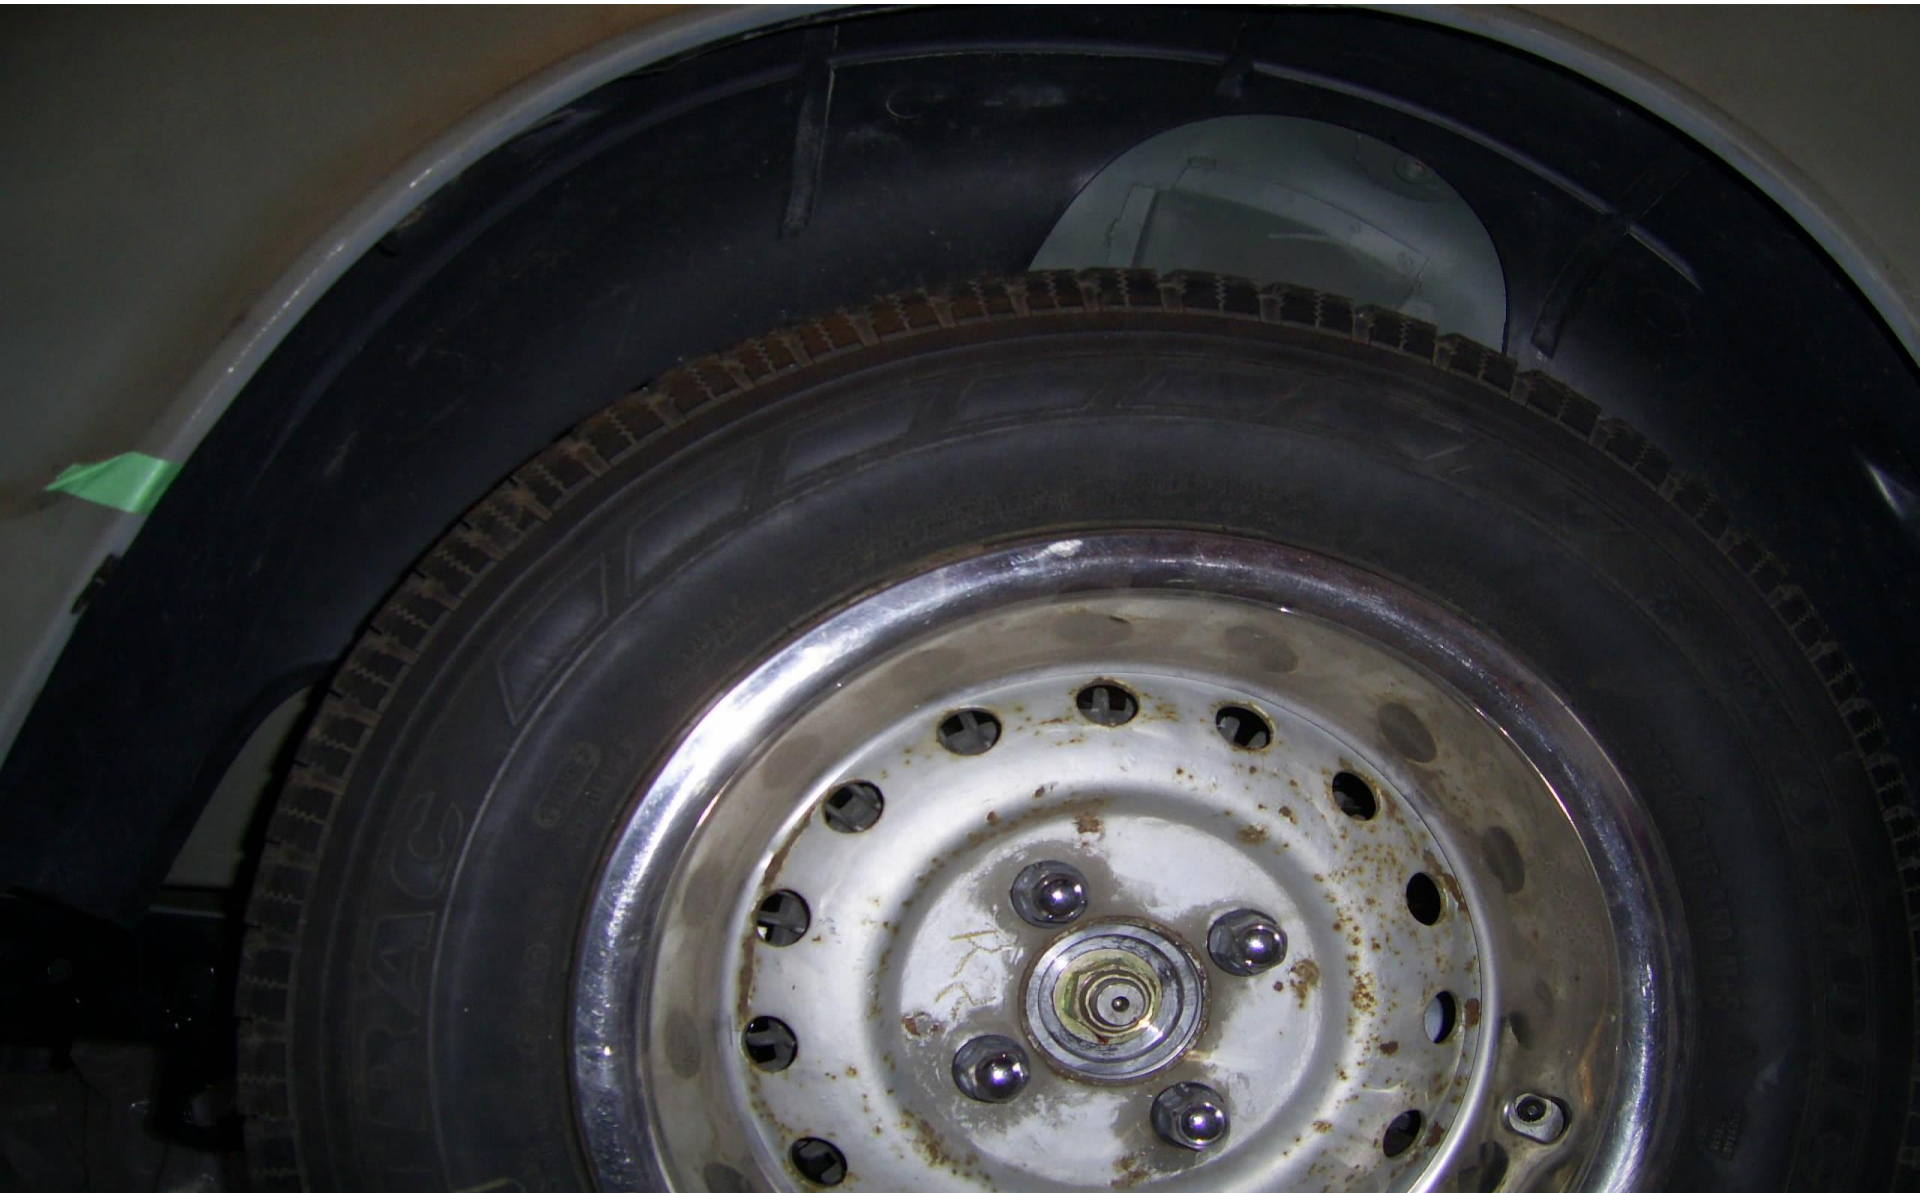
The End Product

- A relatively cheap modification to fix a know problem.
- The fit is pretty good, particularly around the IRS bumper stop, but not as perfect as custom inserts - this is a 95% solution.
- Final mounting will require 4-6 rivets, screws or clips to attach insert to inner body wall.
- Home Depot (plumbing) carries a 3/8" diameter soft clear vinyl hose which I split lengthwise, and then put around the edge of the outer fender side of the insert to prevent rubbing and squeaks against the outer wing/fender lip.
