Sidescreen Control Head

Introduction:

Disassembling the unit:

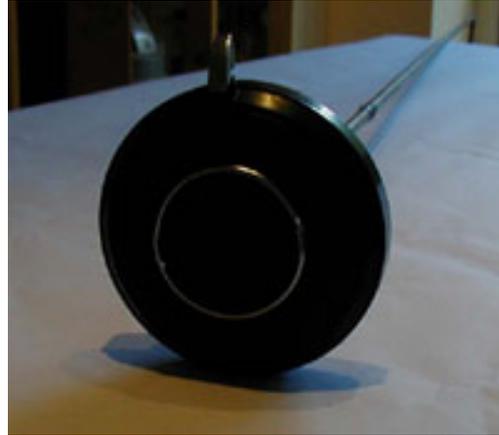
The Control Head removed complete

Firstly undo the three hex drive grommets in the steering wheel boss. You then have to go to the front of the car and disconnect the four wires. Now undo the large nut on the front face of the steering box. This will reveal an olive, just like a piece of plumbing, and the oil will begin to run out of the steering box. Thread the nut and the olive off the wiring and store safely. Once you have done this you should be able to go back into the cockpit of the car and extract the whole assembly from the steering wheel. The whole thing is about 5 feet long. It is possible only to partly withdraw the assembly and work on it in-situ, however experience has taught me that the rest of the operation is a dining room table job in warmth and good light! For more detail of this part of the operation refer to your Workshop Manual.

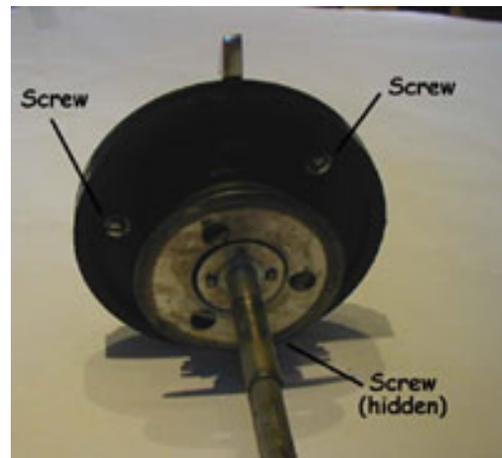
Rear view of Control Head Assembly

The next stage is to remove the horn push and the front face. This is done quite simply by

unscrewing the three large screws on the reverse of the unit. Once the screws are undone the front face will fall away, together with the horn push, the horn spring and a locating button that sits in the centre of two brass contacts mounted on a piece of circuit board type material. There is also a brass contact plate on the rear of the horn push button. This should be stuck in place but sometimes I have found that the glue has failed. The button, which retains the horn push spring often remains in place. It is usually a tight, fit hence the reason it does not appear on the next photograph.

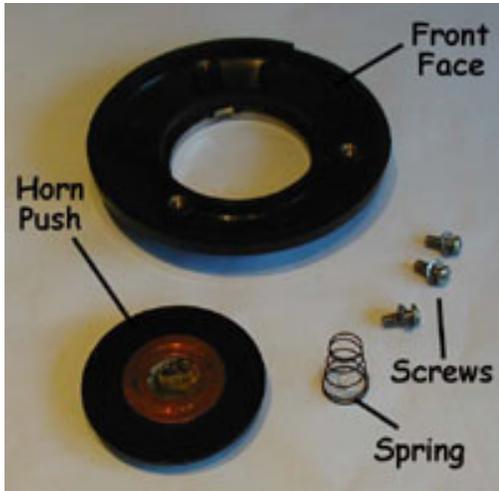
Removed Components

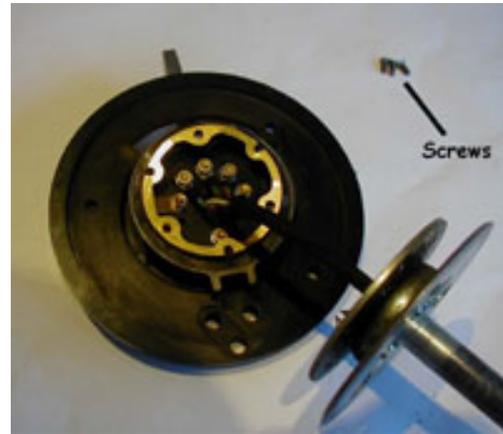
Rear view of Control Head removed from Backing Plate, note the three screws!

Next you need to undo three screws in the rear of the unit, to give you access to these you must line up the three holes on the back plate with the screws. Once these are removed the

control head is free to be pulled away from the backing plate, but be careful of the wires,
© Clive Elsdon

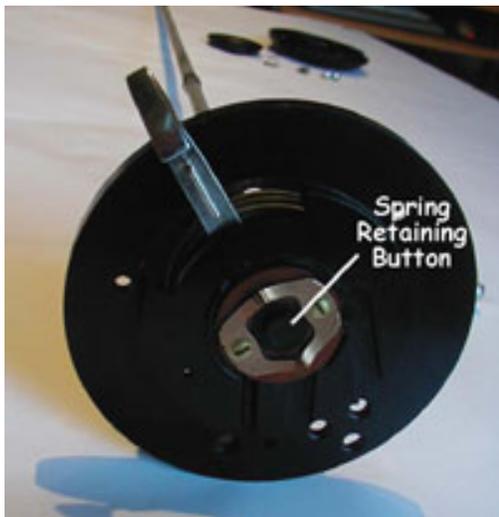
Front view of assembly with face removed

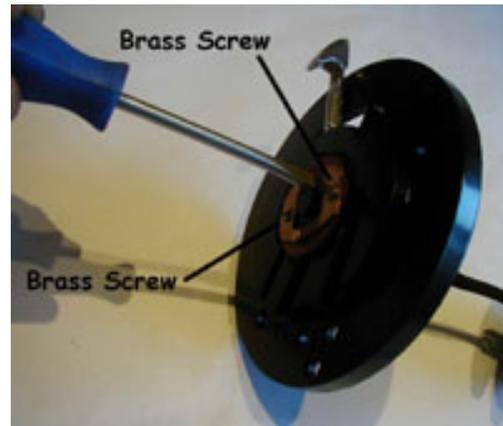
Removing the Brass Screws

Now we are about to start on the bit where it all springs apart! On the front face there are two brass screws, which pass through the

circuit board type material and the two halves of the remaining unit. They also pass through one other component. In one case it's an end connection on a wire and in the other case it's a lug on a brass ring. The screws are secured by brass nuts on the reverse side. Both these screws must be removed, this frees the brass horn contacts from the front of the unit. Once the operation is complete the brass ring on the rear will also be free and you will have a loose brown and black wire! If the button in the centre of the horn contacts had not come away previously, it will have done now.

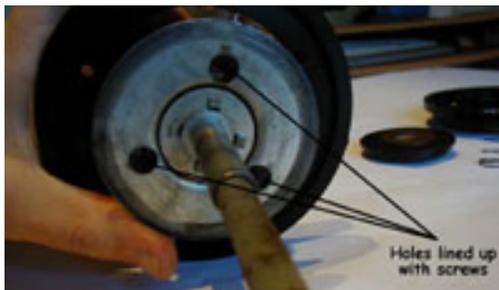
Rear view showing holes aligned

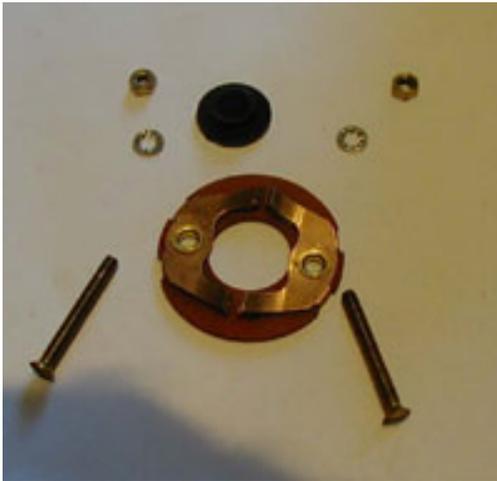
The components just removed (including the button that retains the horn push spring)

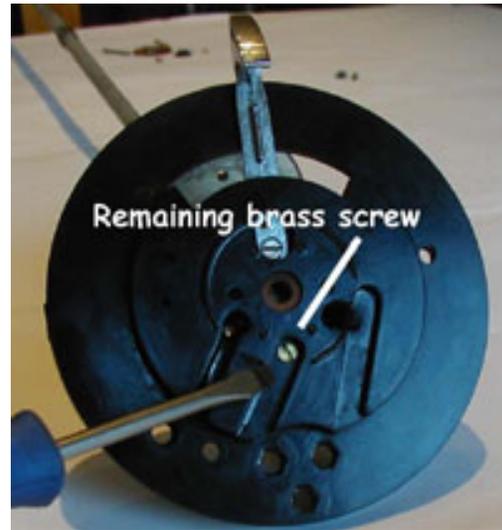
The remaining brass screw

is advisable to hold the two halves together and release them as slowly as possible!

This last action will have revealed one remaining brass screw holding the two halves of the unit together. You will note that once you remove it that this screw is shorter than the other two. The removal of this screw results in the whole thing springing apart, so it

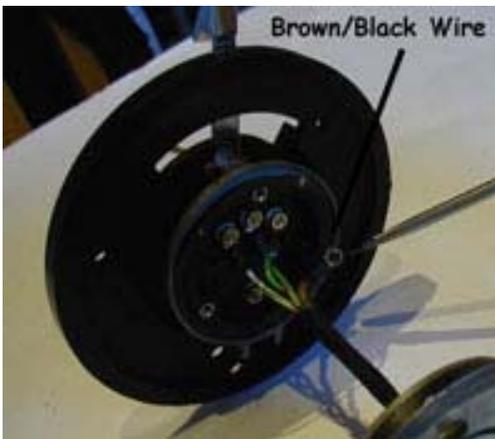
The brown and black wire freed

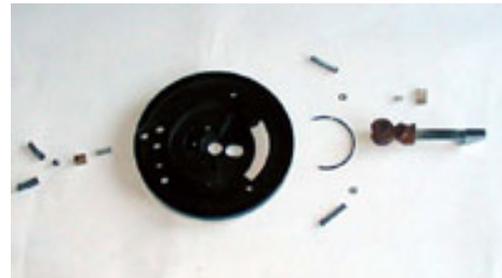
The remaining components laid out

- 1No. Centre pivot with thumb lever [a]
- 1No. Curved metal guide [b]
- 2No. Washers [c]
- 2No. Long Springs [d]
- 1No. Short Spring [e]
- 1No. Brass Contact [f]
- 1No. Medium length spring [g]
- 1No. Wheel holder [h]
- 1No. Wheel [j]
- 2No. Hinged followers [k]
- 1No. Casing [l]

There are a number of small parts inside, and it is impossible to separate the two halves without these falling out!

It's important that you check off the components that have come out, they are all essential! Excluding those we have already removed there should be:

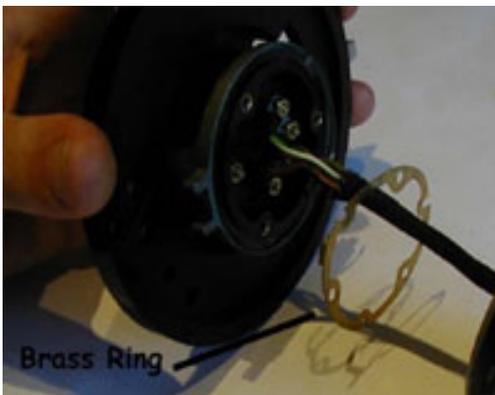
The Brass Ring freed also

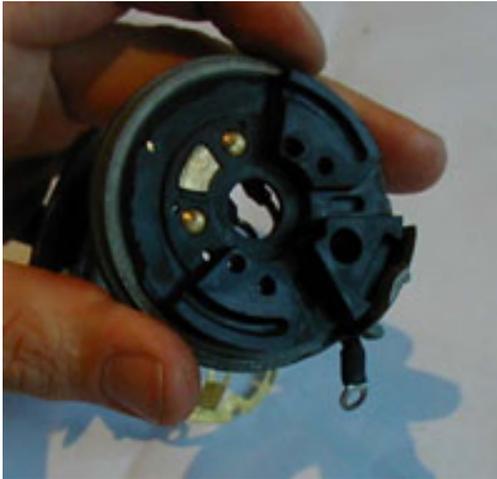
Front view of unit

On the other hand we have circular moulded component still attached to wiring. These wires are released by removing the three remaining nuts on the back of the unit.

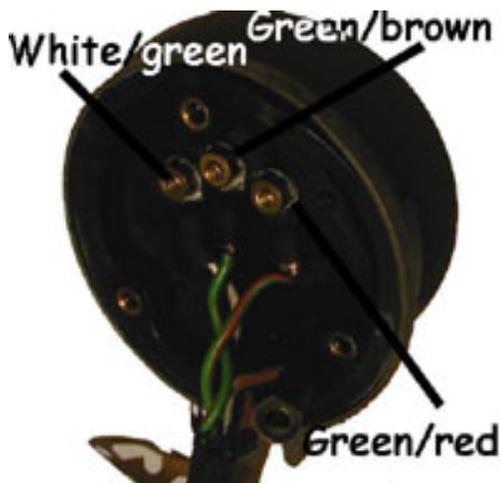
The order of wires, from left to right, viewed from the rear is white body with green stripe,

Rear view of unit with the three remaining wires attached

green body with brown stripe and finally green body with red stripe. For those who want to know, these are your indicators! There is also a metal ring left on the unit, it can just be seen inside the circumference. It can be seen removed in the last picture of this section. I won't bother including a picture of the wires removed, and the description of the re-assembly will assume that these have already been re-attached.

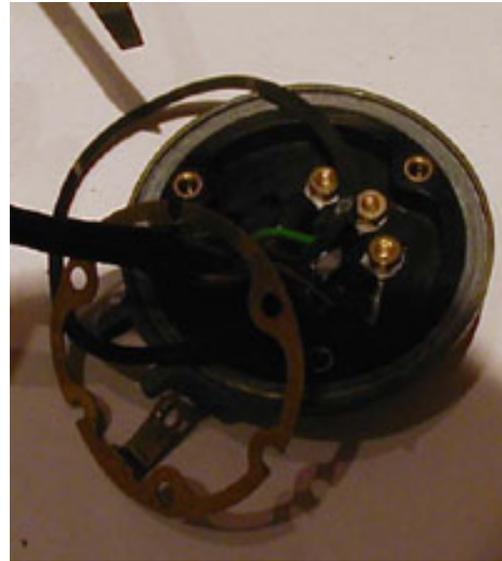
Showing the metal ring
