Triumph Stag Brake Master Cylinder Overhaul Notes

David Kirk
15 June 2001

David Kirk, following the overhaul of the brake master cylinder after the seals had failed, wrote these notes.

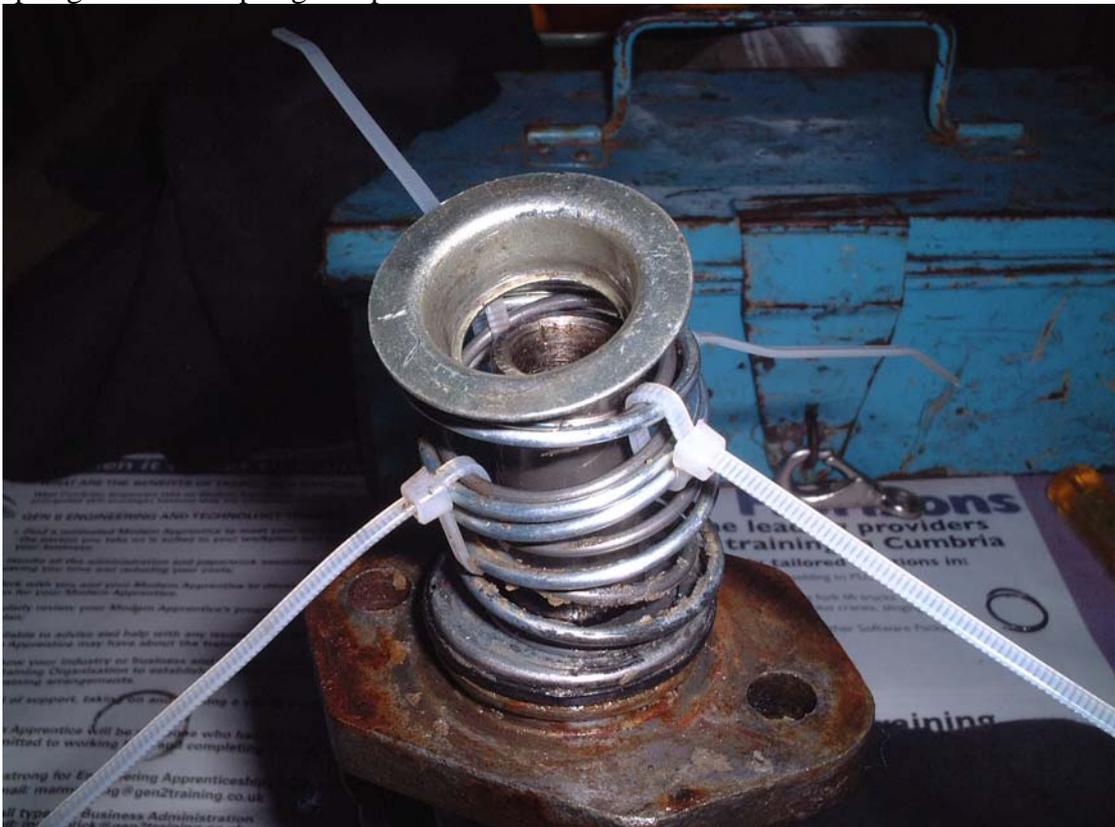
- 1.1. Compress the double spring and remove the “coil” type circlip that retains it. A good tip here is to use two or three cable ties wrapped around the coils of the spring to act as a spring compressor.

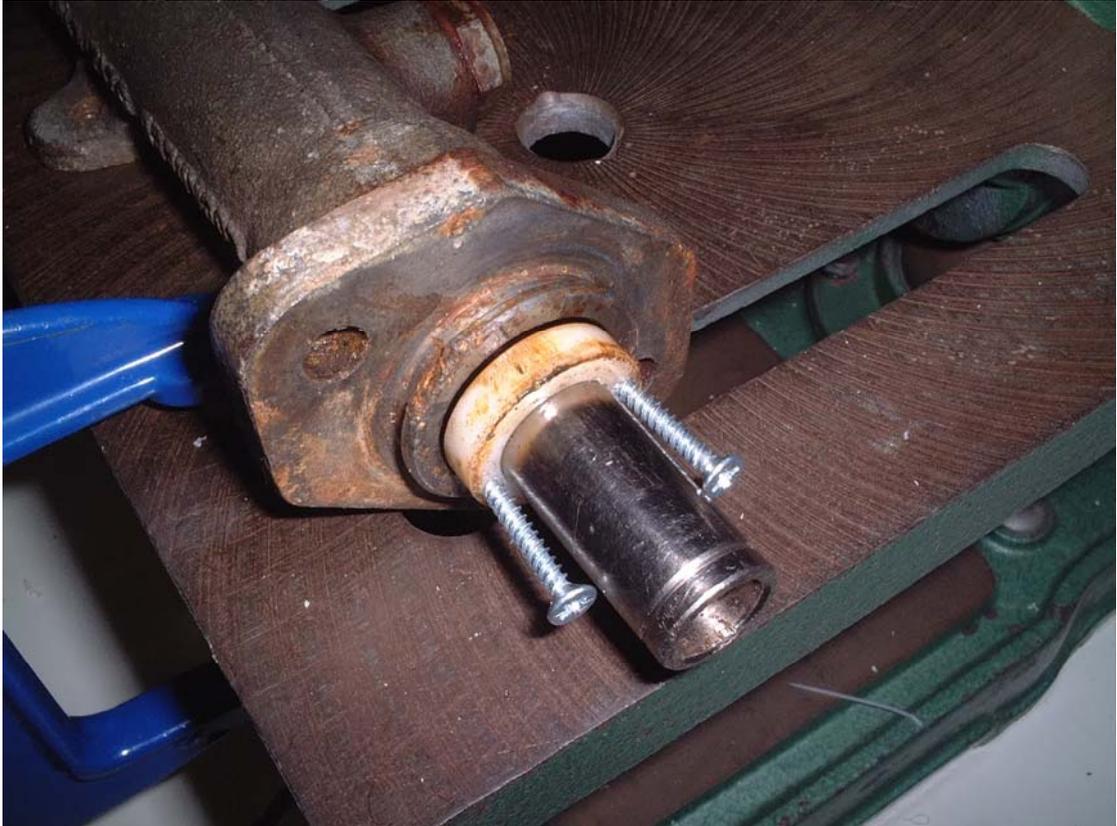
- 1.2. Once the springs and associated washers have been removed, remove the internal circlip. The next item to be removed is a nylon washer. This is a tight fit in the bore and the best method for removal is to drill two small pilot holes in the washer diametrically opposite to each other. Do not drill these holes the full depth of the washer. Then fit two self-tapping screws into the pilot holes and these can then be used to pull the washer out. Although now damaged, a new washer is included as part of the repair kit.

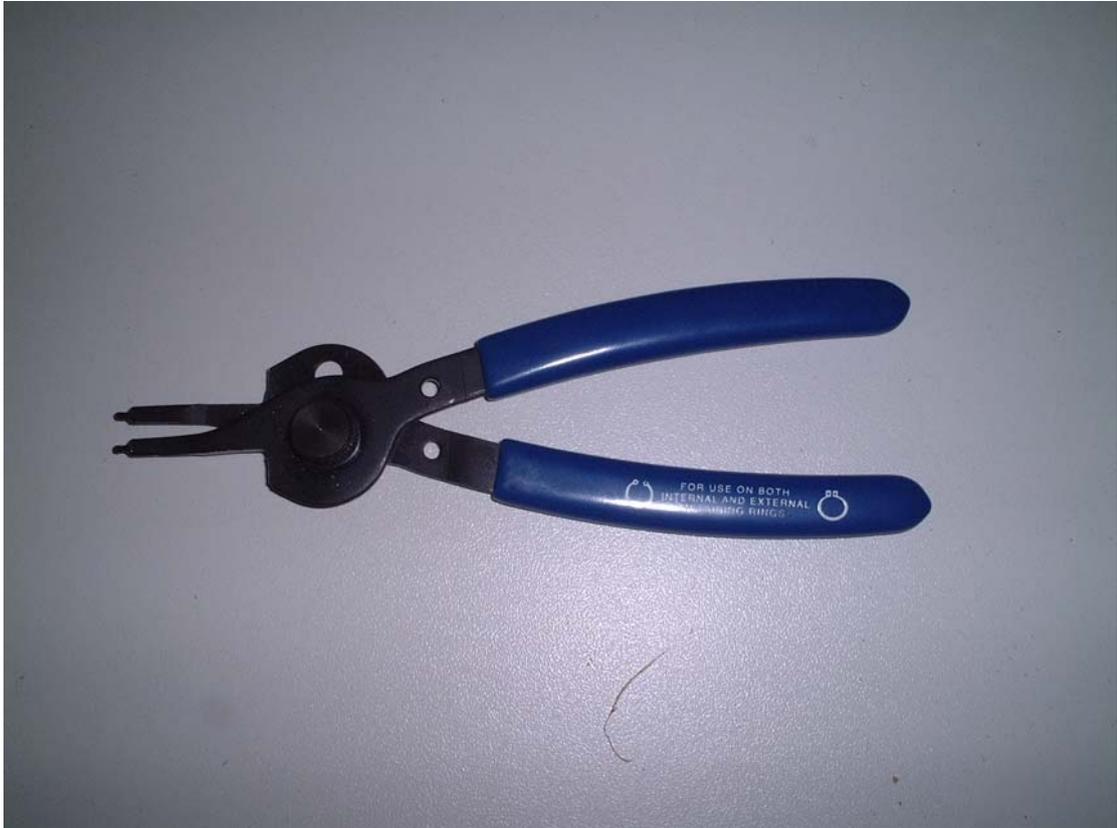
- 1.3. Once the nylon washer and associated metal washers have been removed (note the order of these as they come out) another internal circlip is exposed. This is quite difficult to remove, as it is some way down the bore. I used a pair of cheap universal circlip pliers but had to file them down considerably to reach down the bore.

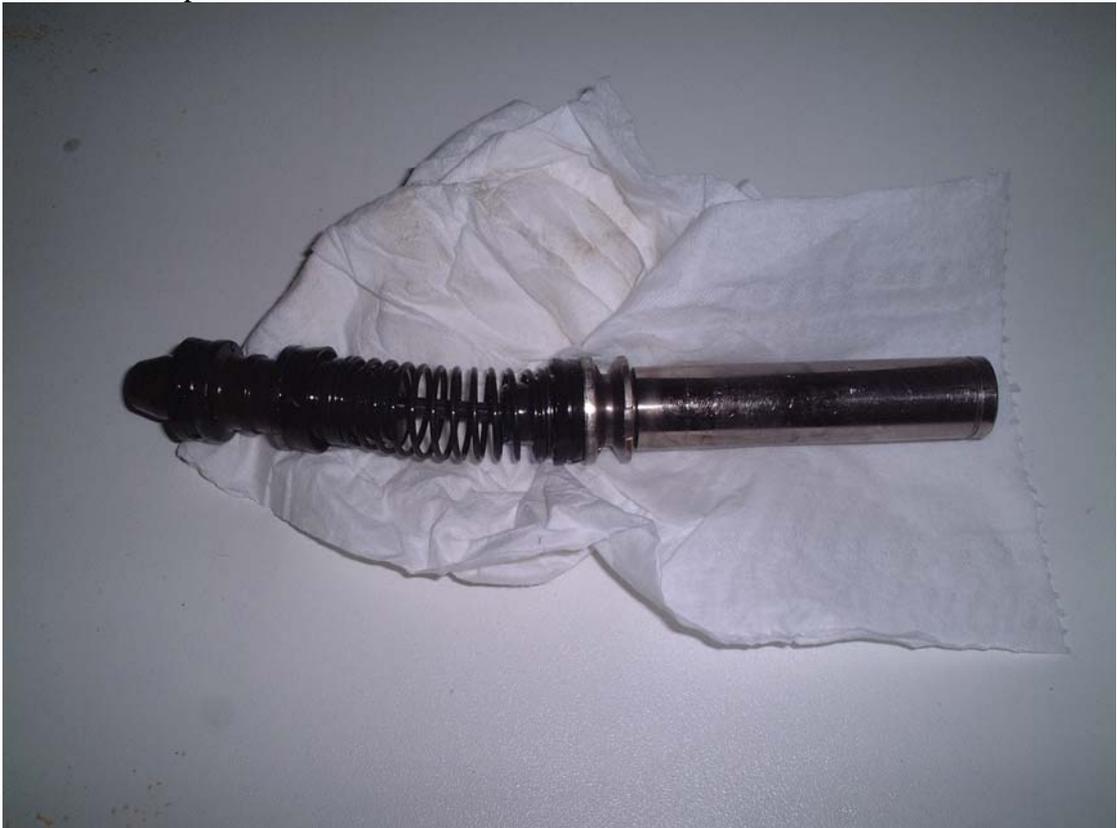
- 1.4. After successful removal of the circlip the con rod and pistons assembly can be extracted complete.

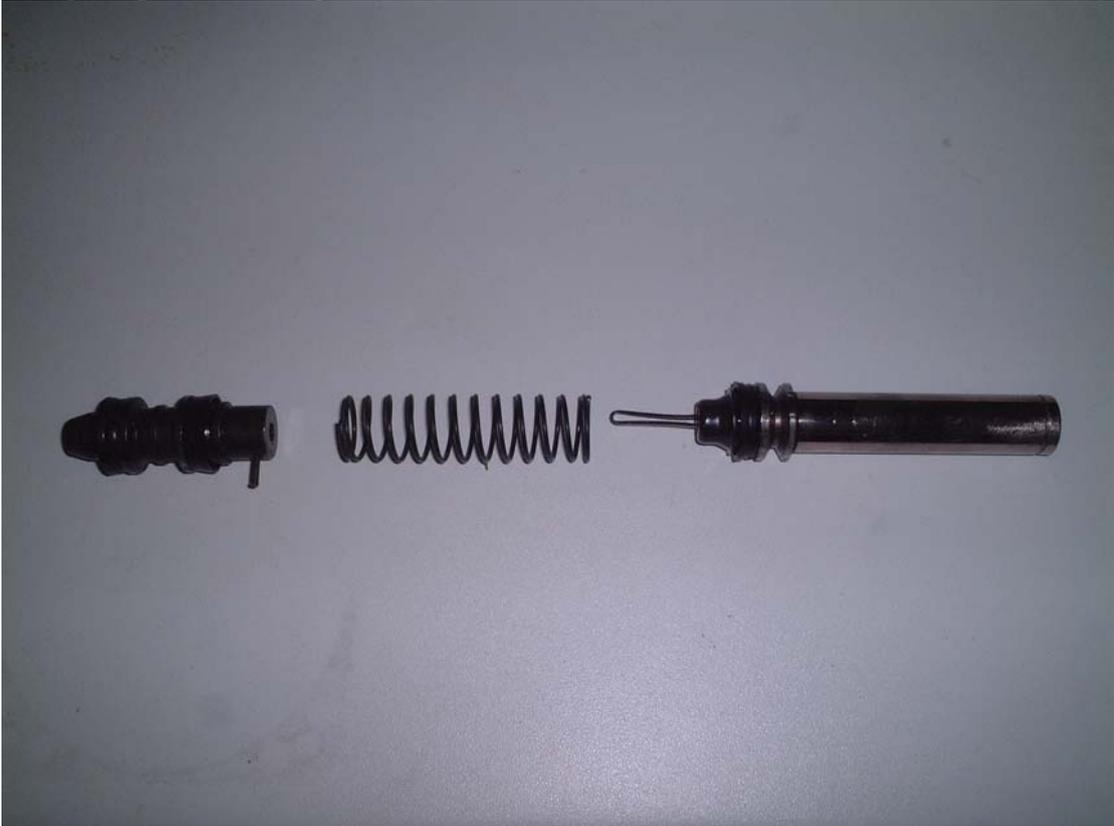
- 1.6. There are three seals that need replacing. The inner two can only be reached by separating the double pistons from each other. To do this the roll pin that retains them has to be tapped out. A suitable diameter drift should be used. A snapped 2mm diameter drill bit is about right. At this stage it is important to support the assembly carefully while tapping out the roll pin. It is more important on reassembly as damage to the new seals may occur unless the work surface is soft enough to prevent damage to the new seals.
