A Simple Solution for Separating Axle and Hub

By Dave Plummer (HAWAIIICJ) originally published on British Car Forum
26 November 2016

This tool works for the Girling axles found in late TR3 and TR4 live axle vehicles with the large threaded hubs.

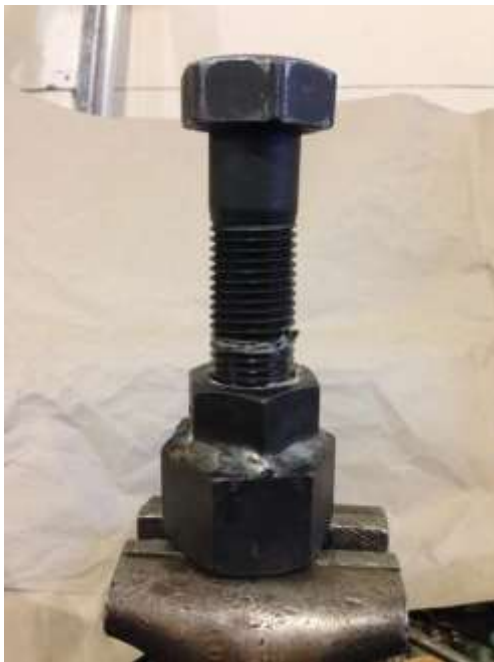
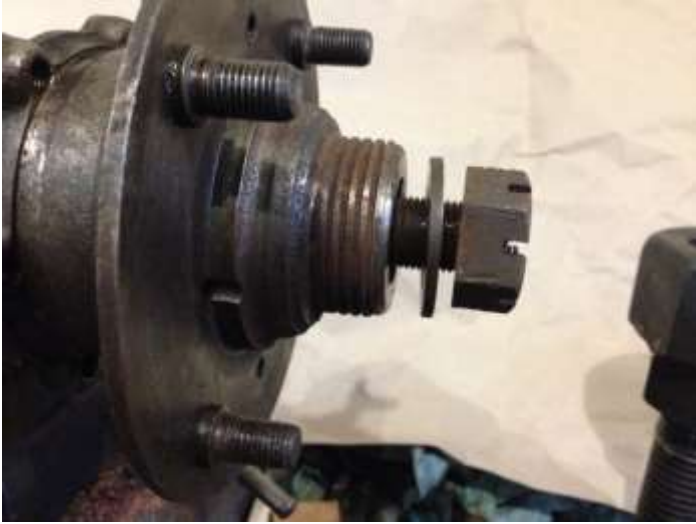
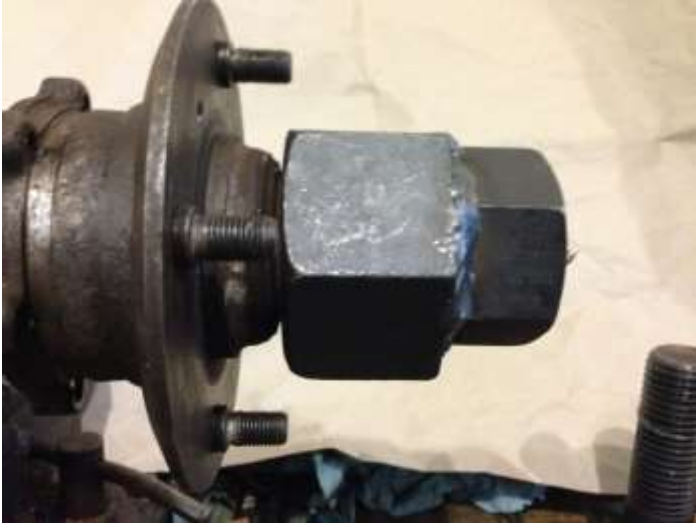
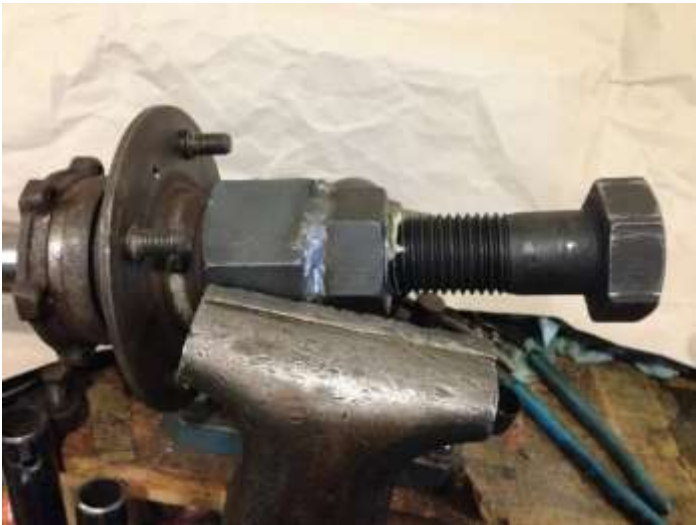
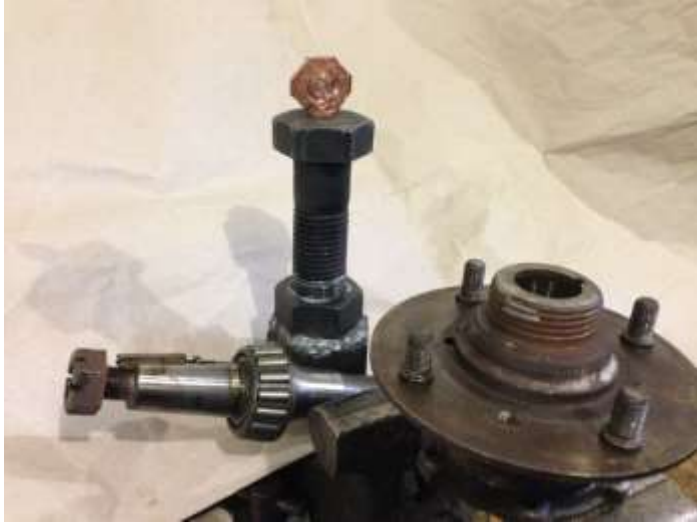
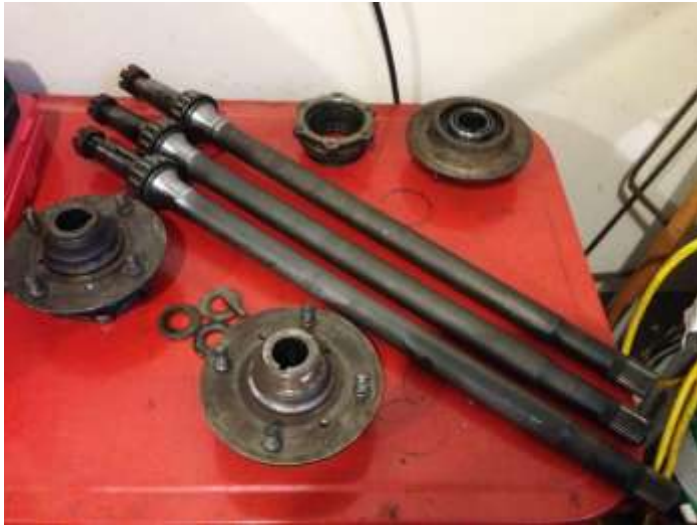
Center the 2 nuts on top of each other and weld them together, I held them together with the bolt during the weld. I had the heat on the MIG turned way up and the nut assembly took about 45min to cool off enough to move but still too hot to handle by hand.

I then took and cut the copper bar to produce a 1-1/2" square piece and then trimmed the corners to fit loosely into the large nut, this will be what protects the end of the axle from damage during the force applied by the bolt (forcing screw). Lubricate the end of the forcing screw (bolt), bolt threads and the threads of the small nut with lithium grease.

Place the axle assembly vertically, place the copper disc on the end of the axle, thread the nut assembly with the large nut threading onto the external threads of the hub. The nut should thread on until tight, there will be a 3/16" gap between the bottom of the nut and the 1st step of the hub. Install the forcing screw into the small nut and secure hand tight. I then reset the axle puller assembly with the large nut in the vise and used a 2-1/4" x 3/4" drive impact socket (Sunnex obtained from Amazon \$23.00) with a 1/2"-3/4" adapter and a 1/2" air impact wrench. I purchased a 3/4" Earthquake XT from HF but it is on backorder!

I tightened the bolt as tight as possible and then hit the end of the forcing screw with a large hammer, the 2nd hit had a tone change, I then further tightened and the forcing screw turned in 1/2 a turn and the axle was loose in the hub. I repeated this procedure 3 times with the same success, on each axle assy. The first assembly had a damaged hub and was sacrificial, I purchased it from Ebay for the axle shaft only. One of the originals has a damaged inner seal surface.
